CASE STUDY

BUCKLEBOO STATION - SA, AUSTRALIA

ADVANCED METHODS IN GROUNDWATER EXPLORATION LOCATING PREVIOUSLY UNDETECTED WATER SOURCES FOR DROUGHT PRONE REGIONS

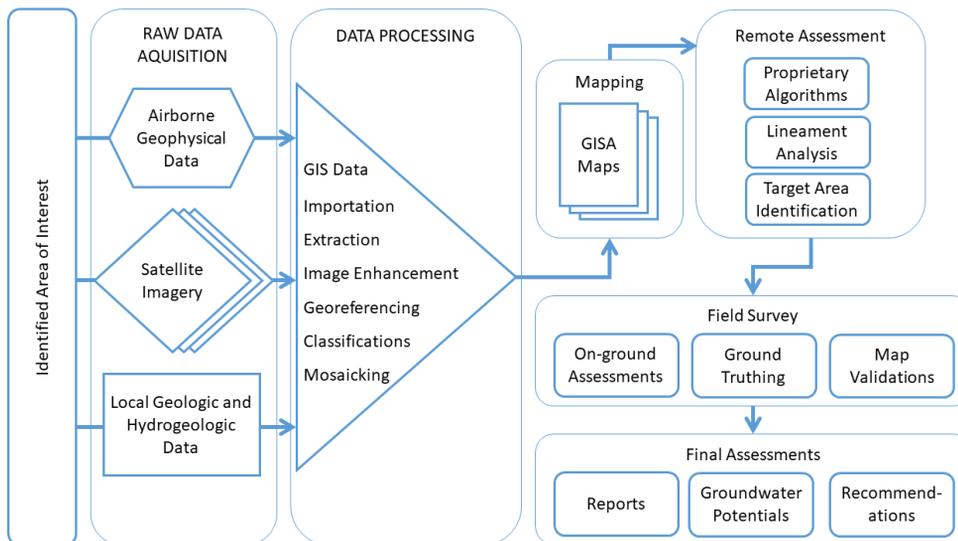
Figure 2. Process model of groundwater detection methodology

The GISA team collected both raw and processed datasets from available sources including satellite imagery, digital elevation models, soils, geology, geophysical, morphology, etc.

Next, GISA technical staff performed integration, processing, analysis of the geospatial data in geographic information systems (GIS) software using specialized, proprietary algorithms and techniques. These unique methodologies allow for the identification of anomalous indicators that are subsequently used for targeting deep groundwater systems, resulting in identified areas of interest for field surveys.

Subsequently, GISA conducted a field survey for verification of initial findings. Based on the field survey, six sites were identified, and two were highly recommended to the client as having high probability for ample groundwater resources.

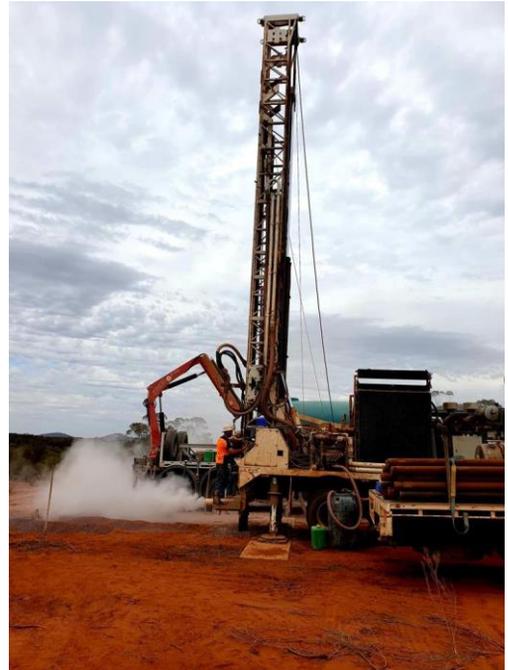
Figure 5. Drilling at Site 3, January 2020.

Significant water bearing zones were encountered at 243 and 320 metres. The flow rate at 243 metres was observed to be approx. 20,000 litres per hour with a standing water level at 24 metres. However, salinity levels of about 5,000 ppm were observed.

Hard rock encountered at both sites necessitated proper planning and real-time modifications by the drillers in order to succeed.
